Barnard Castle County Durham

Case Study

Driveways and Parking

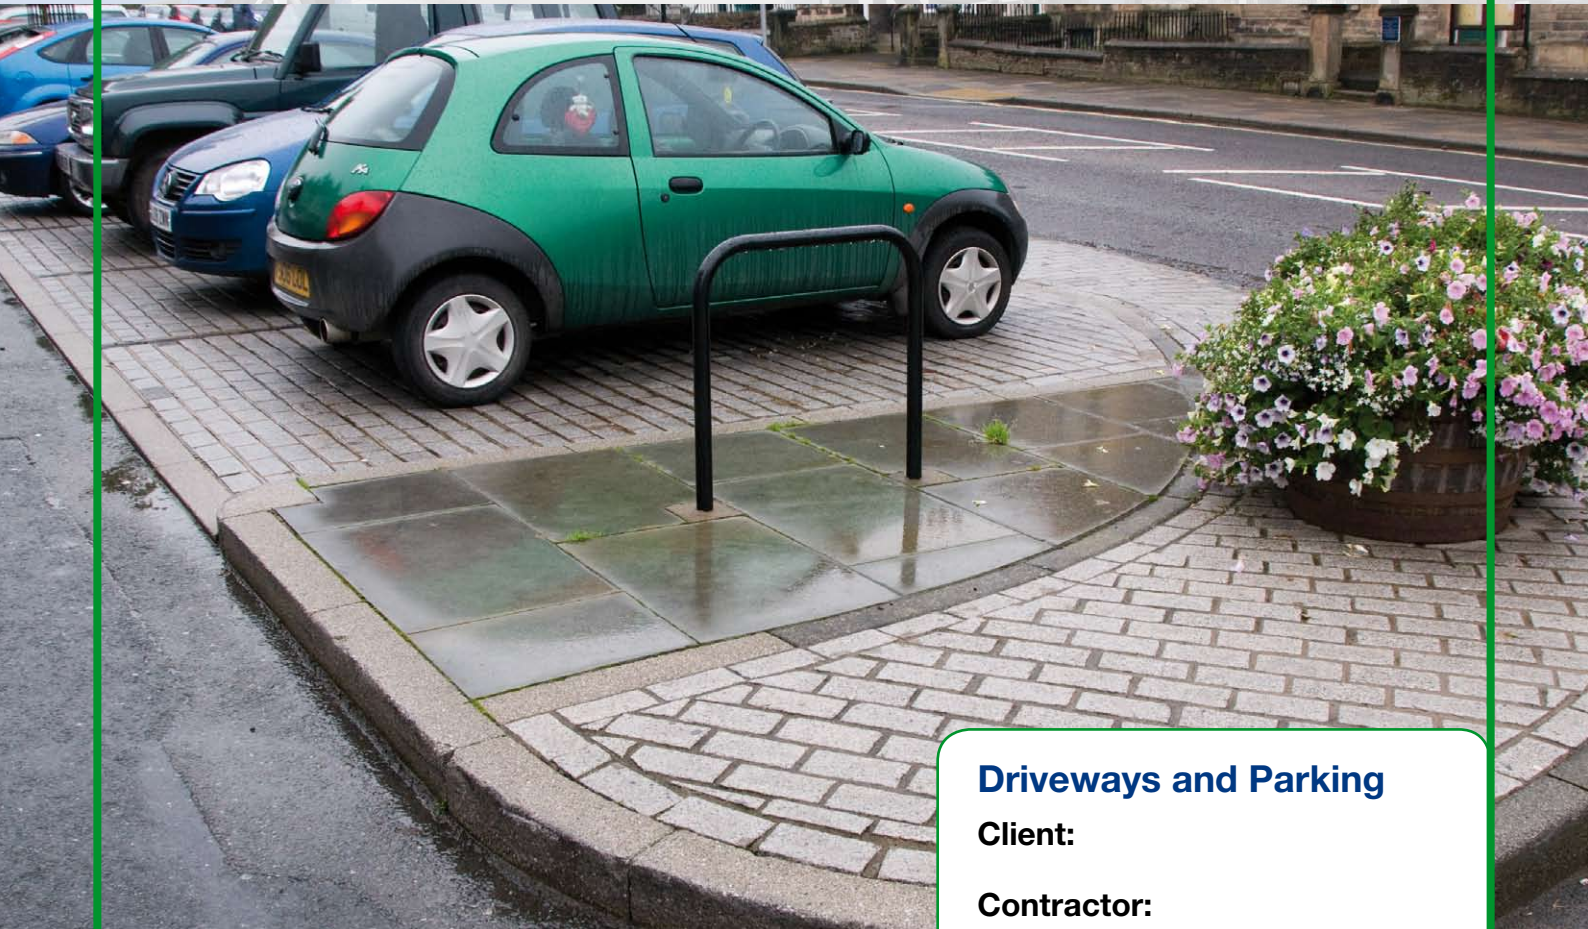
Paved parking areas alongside the main road into Barnard Castle had to be completely refurbished as they were potentially becoming dangerous, as well as unsightly, due to the breakdown of the pavement jointing compounds. The Council had tried modern cement and polymer cement based products, even epoxy mortars, but these all have inherent problems for application on site in damp / wet conditions, plus they are not suitable for use at low temperatures.

The Authority has finally solved the problem by relaying new and reclaimed granite setts with **GftK 850** Pavement Jointing Mortar from **NCC Streetscape**, which is also designed to withstand the vibration and loading from frequent traffic, including heavy retail deliveries.

As an additional advantage, each of the 180 M² areas, could be fully jointed and completed by a three man crew in a single seven hour shift and then quickly opened for traffic – even in the low temperatures and wet weather!
